## Introduction

Two C3 Submersible Fluorometers were deployed in the San Francisco Bay for a period of 1 month, from March 15, 2012 to April 18, 2012. Both units were equipped with a Chlorophyll sensor (Sensor 1) used to detect the fluorescence of chlorophyll from algal cells. To one of the units, antifouling copper tape was applied to the optical head (designated as Copper Unit), and the other unit was used as a control (designated No Copper Unit).

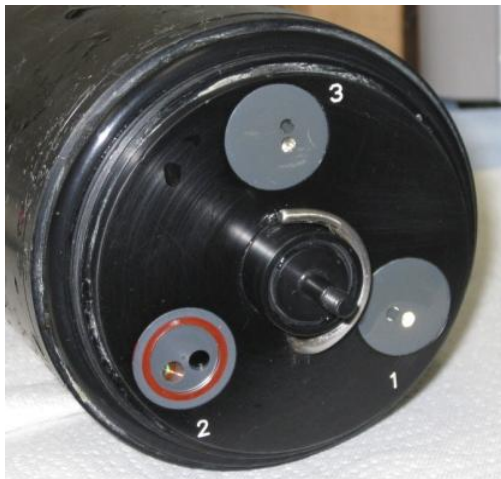
**No Copper Unit**

Instruments were deployed with C3 Submersible Fluorometer's standard shade caps and no wipers were used for this deployment.

After recovery, visual observations indicated that there was more growth on the No Copper Unit's optical head than the Copper Unit. Sessile organisms took hold and were growing on the No Copper Unit's optical head. Covering roughly 55% of the total area of the Copper Unit's optical head with antifouling copper tape was enough to deter growth from sessile organisms that would affect sensor readings. Only a few mobile animals were found living in and around the optical head, but there is no indication of when or how long they were there.

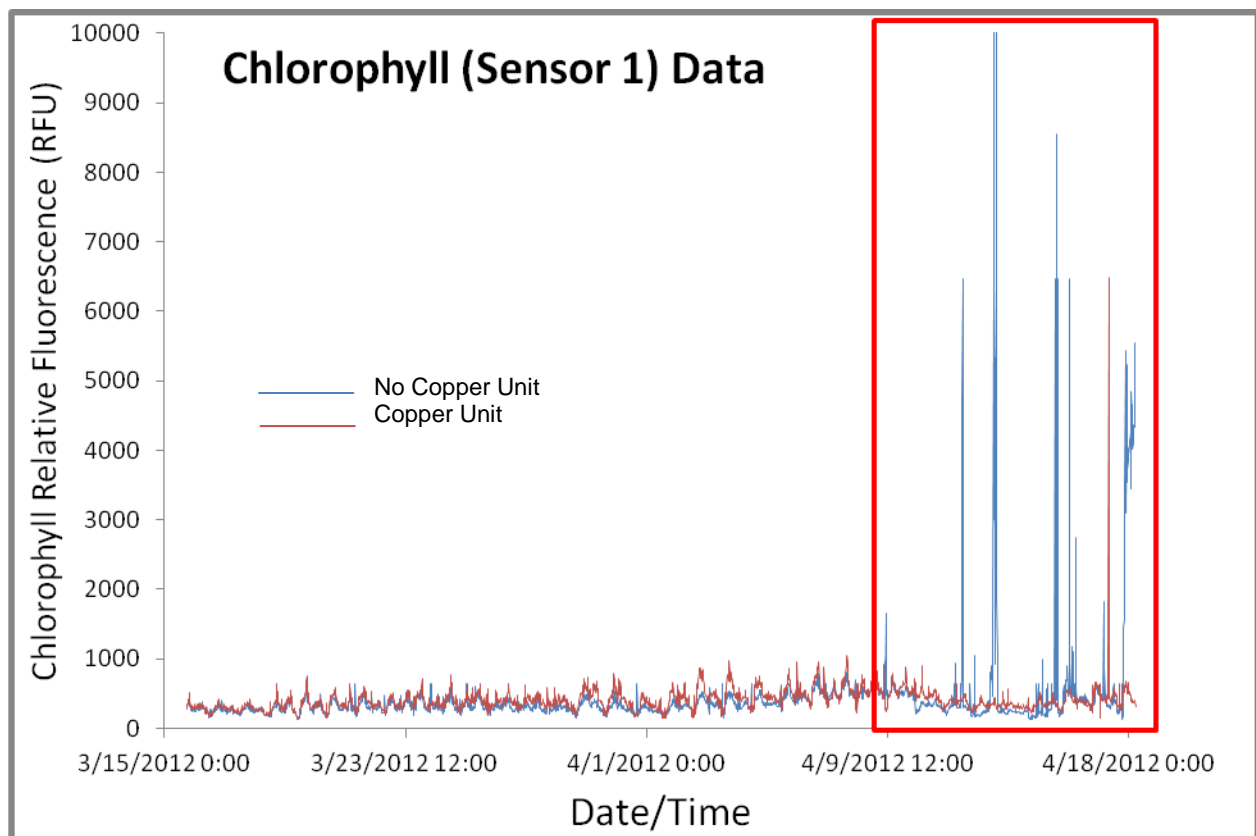
### **Chlorophyll Data**

Data recovered from the units are plotted below as relative fluorescence units over time. The two C3 fluorometers tracked chlorophyll responses over 24 days indicating that the antifouling copper tape doesn't affect sensor measurements or the organisms being detected, phytoplankton in this case, even at low algal concentrations (< 5 µg/L). Around 24 days there seems to be a spike in data from the No Copper Unit and an increase in spike frequencies in that data set from that point on until the units were recovered. In comparison, the Copper Unit showed a stable reading with only one data spike (representing one data point) most likely from a mobile organism passing by the sensor at the time a reading was being made. The stability in the Copper Unit's data set is further indication that copper tape was effective at minimizing organism activity around the optical head and within the Shade Cap for up to one month, the length of the deployment, in a productive system.
