# ClearSignal Coating Controls Biofouling On the Rutgers Glider Crossing

*A Nonstick Coating Gives the Scarlet Knight Glider Permanent Biofouling Control on Trans-Atlantic Mission*

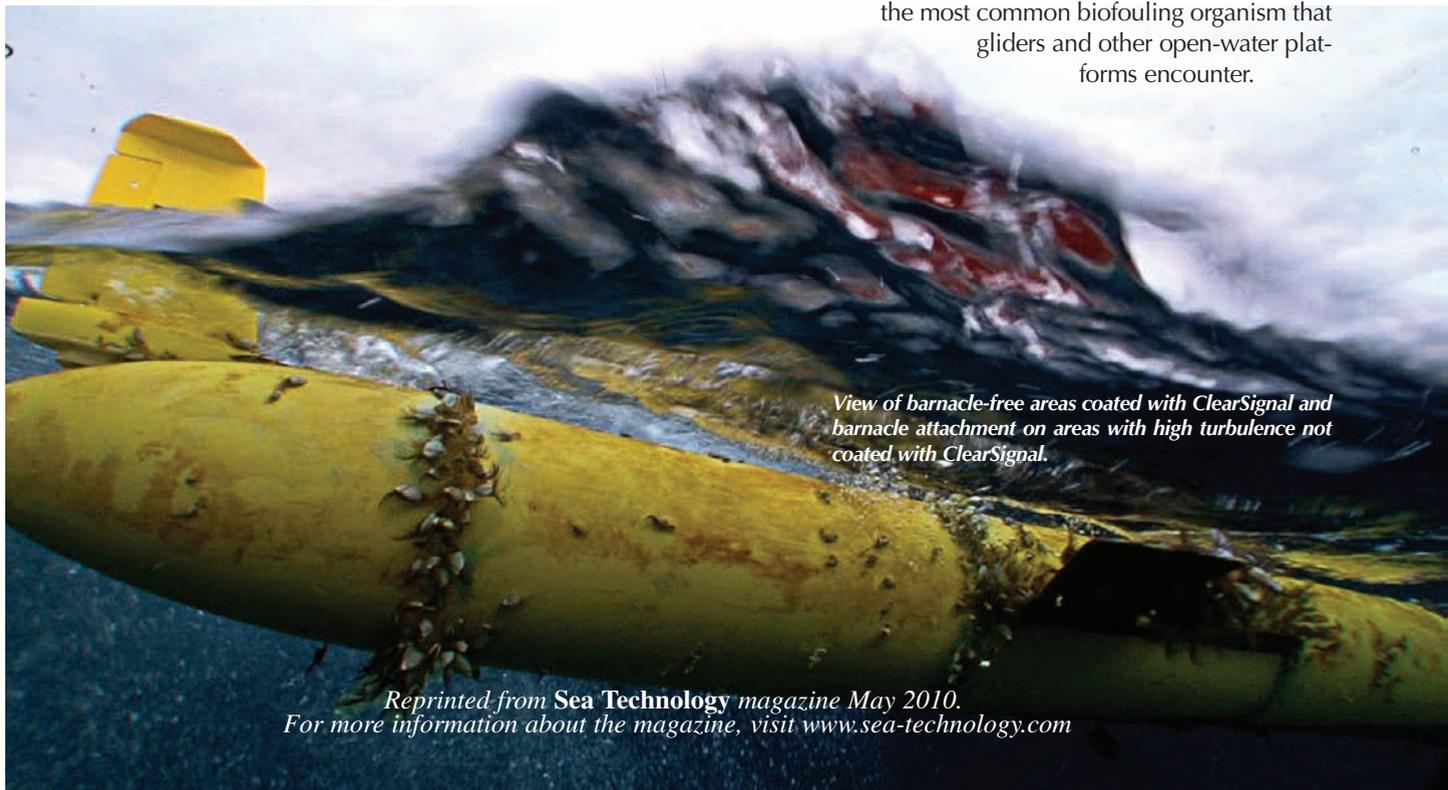
*View of barnacle-free areas coated with ClearSignal and barnacle attachment on areas with high turbulence not coated with ClearSignal.*

The ClearSignal-coated yellow main body sections of the Scarlet Knight were free of all but minor barnacle attachment. The biofouling that did occur was mostly sporadic and consisted of small individual barnacles. It was also noted that some of the sporadic biofouling that occurred on the ClearSignal-coated body were in areas where the biofouling had propagated from the heavily biofouled uncoated sections of the glider.

The glider sections that were not coated with ClearSignal, such as the front-nose-cone pump section aft of the nose cone, connecting seams and the conductivity, temperature, depth (CTD) sensor area had moderate to severe biofouling.

er sections, wing rails and the areas on and near the CTD sensor. It is important to note that these areas suffered from severe biofouling as a result of not being coated with ClearSignal and because of the turbulence generated by the glider surface discontinuities in these areas. It is a known phenomenon that barnacles accumulate in these types of low-pressure turbulent areas.

Since the barnacle settlement occurring on the seams of the glider sections was due to the turbulence generated in these areas and the lack of a biofouling treatment, the prescribed approach for eliminating the biofouling associated with these areas is to tape off these seams to eliminate turbulence and then coat with ClearSignal.

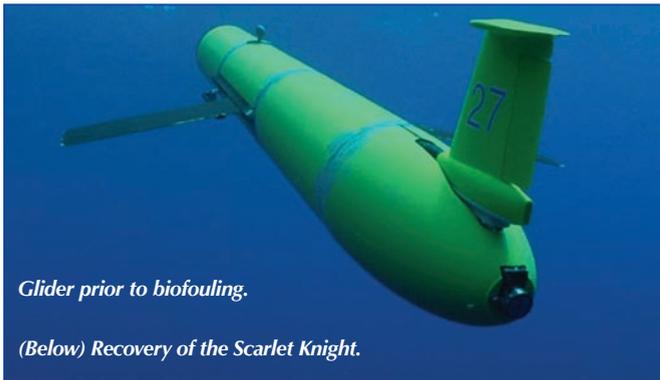
*Glider prior to biofouling.*
